OPEN SPACE & NATURAL RESOURCES
SUPPLEMENTAL MATERIALS

Township Owned Open Spaces

**Upper Dublin Township Open Space &
Environmental Resource Protection Plan Update**
Upper Dublin Township, Montgomery County, Pennsylvania

Site Assessment Report

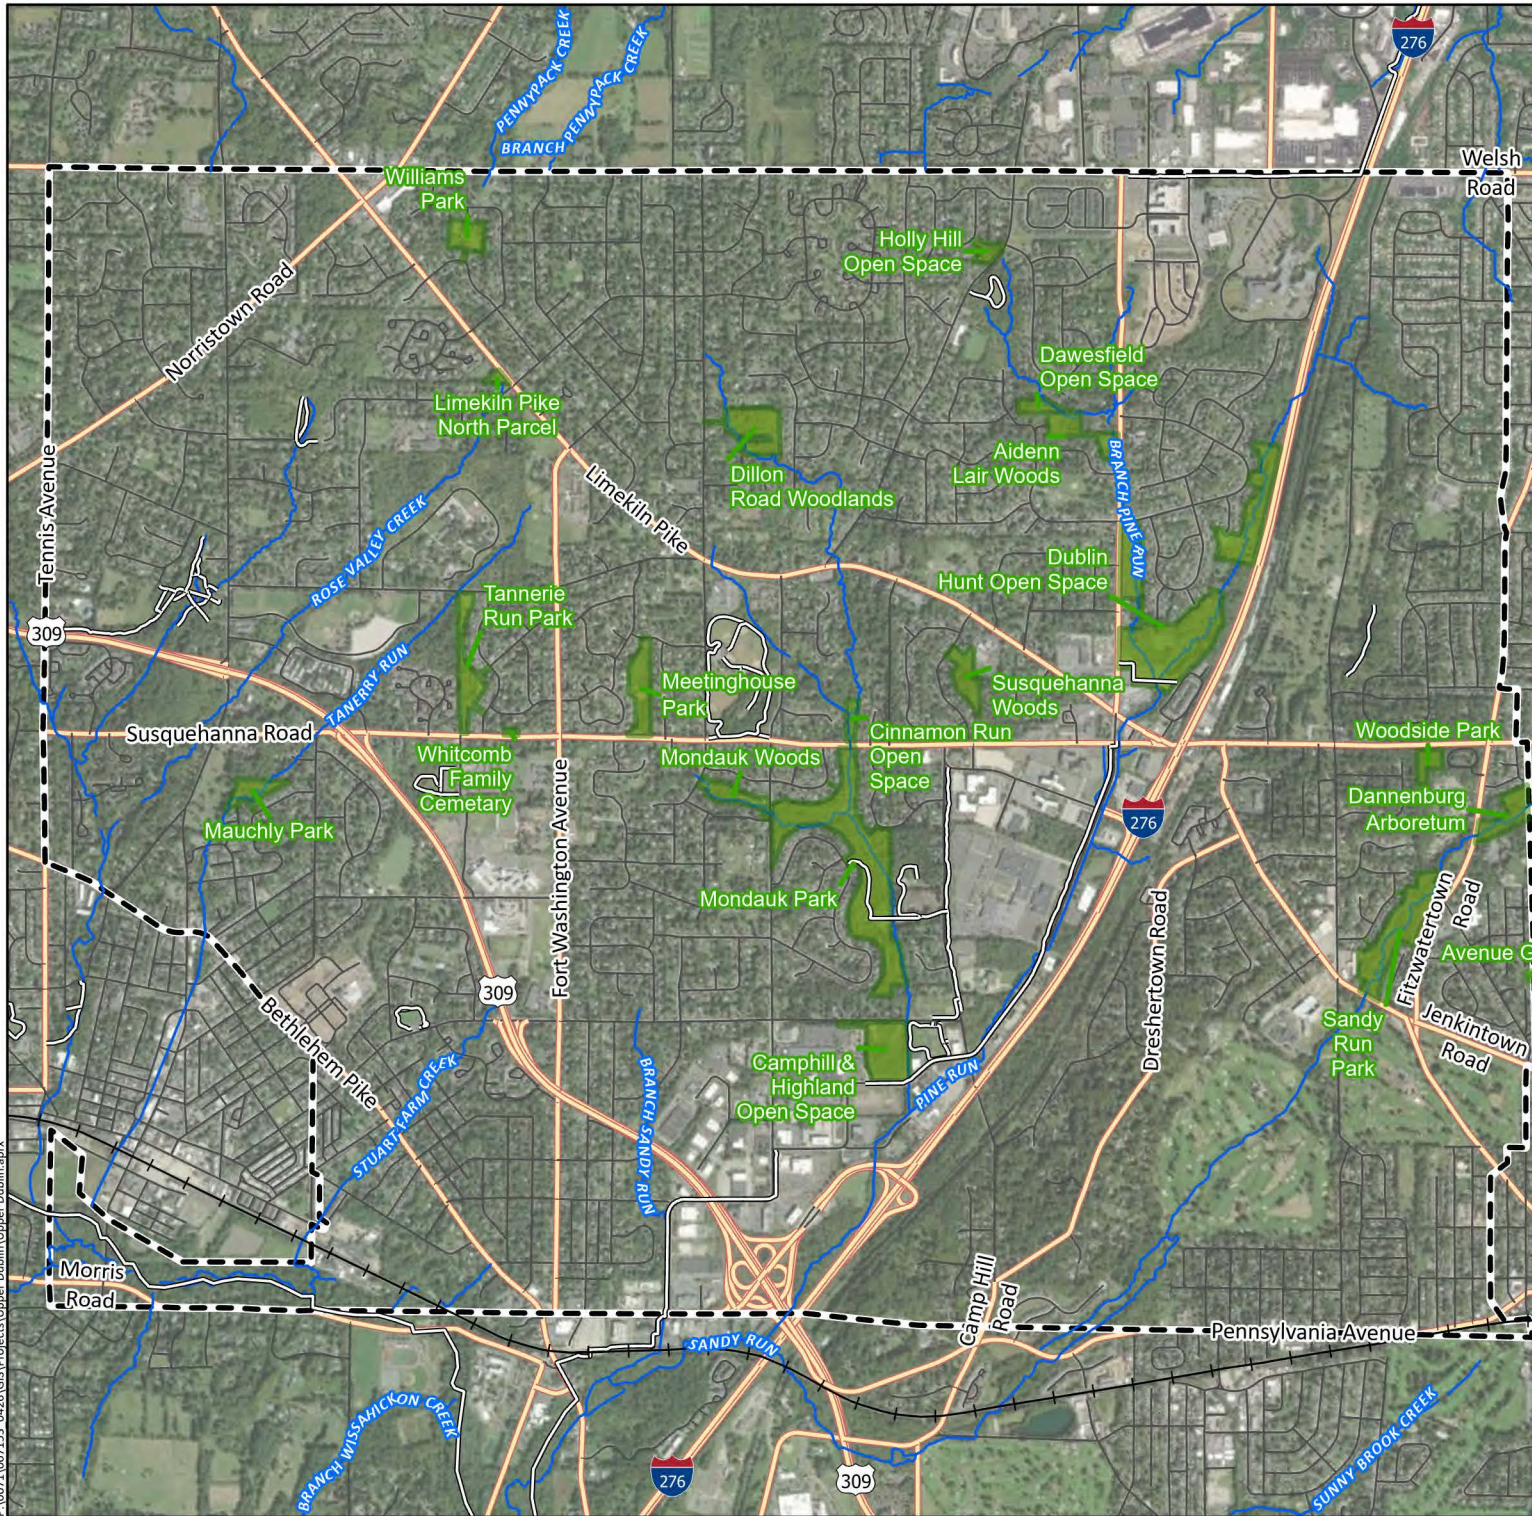
- Passenger Rail
- Trails
- Upper Dublin Township Open Space
- Montgomery County Streams
- Upper Dublin Township Boundary
- State Roads, PA Turnpike & US Routes
- County, Municipal, & Private Roads

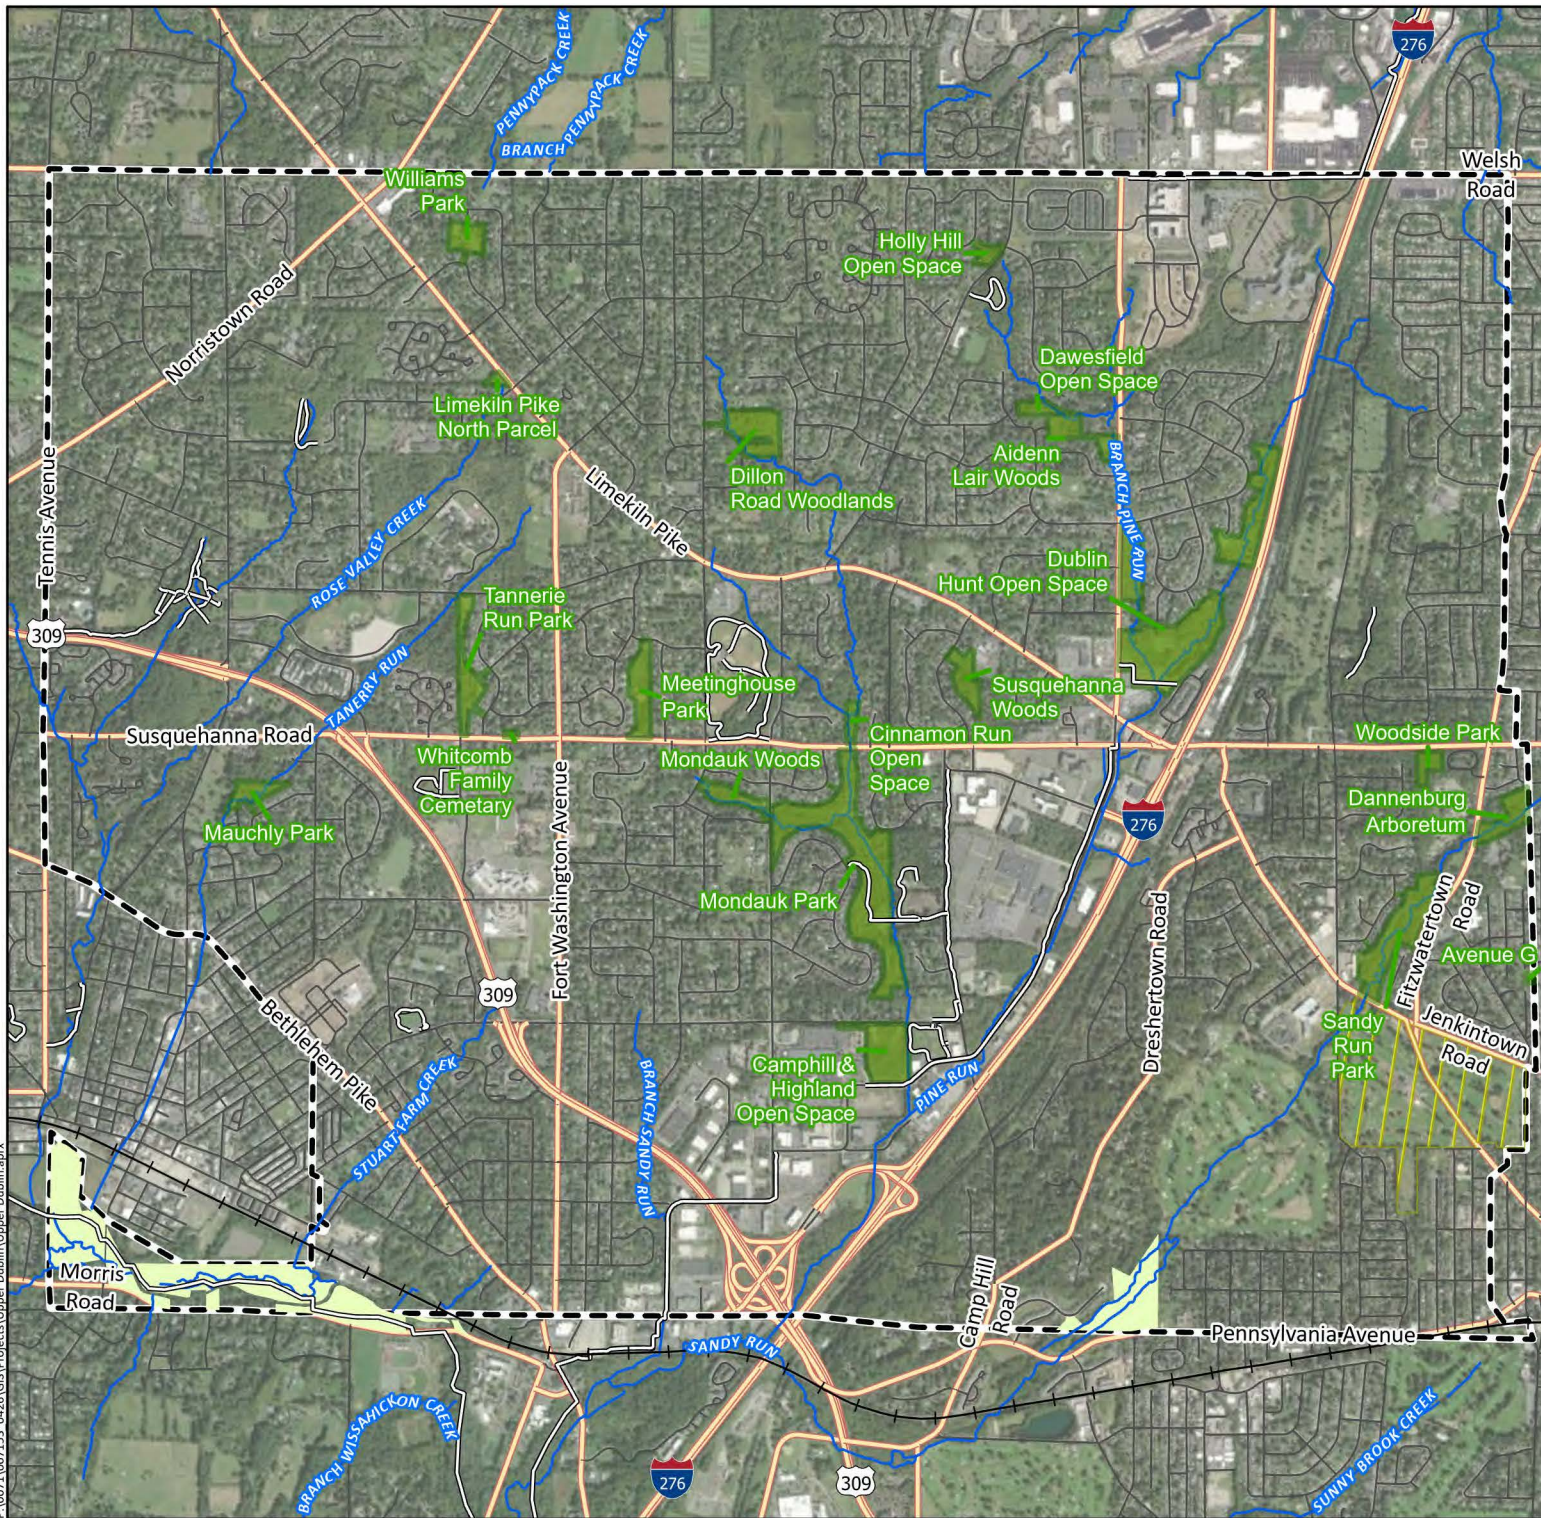
Open Spaces & Preserved Land

- Passenger Rail
- Trails
- Upper Dublin Township Open Space
- Montgomery County Streams
- Conservation Easement
- Wissahickon Trail Preserved Land
- Upper Dublin Township Boundary
- State Roads, PA Turnpike & US Routes
- County, Municipal, & Private Roads
